Shootinglee Trenches 3-5 2015-2019

Data Structure Report

Building 2

Peeblesshire Archaeological Society 2024

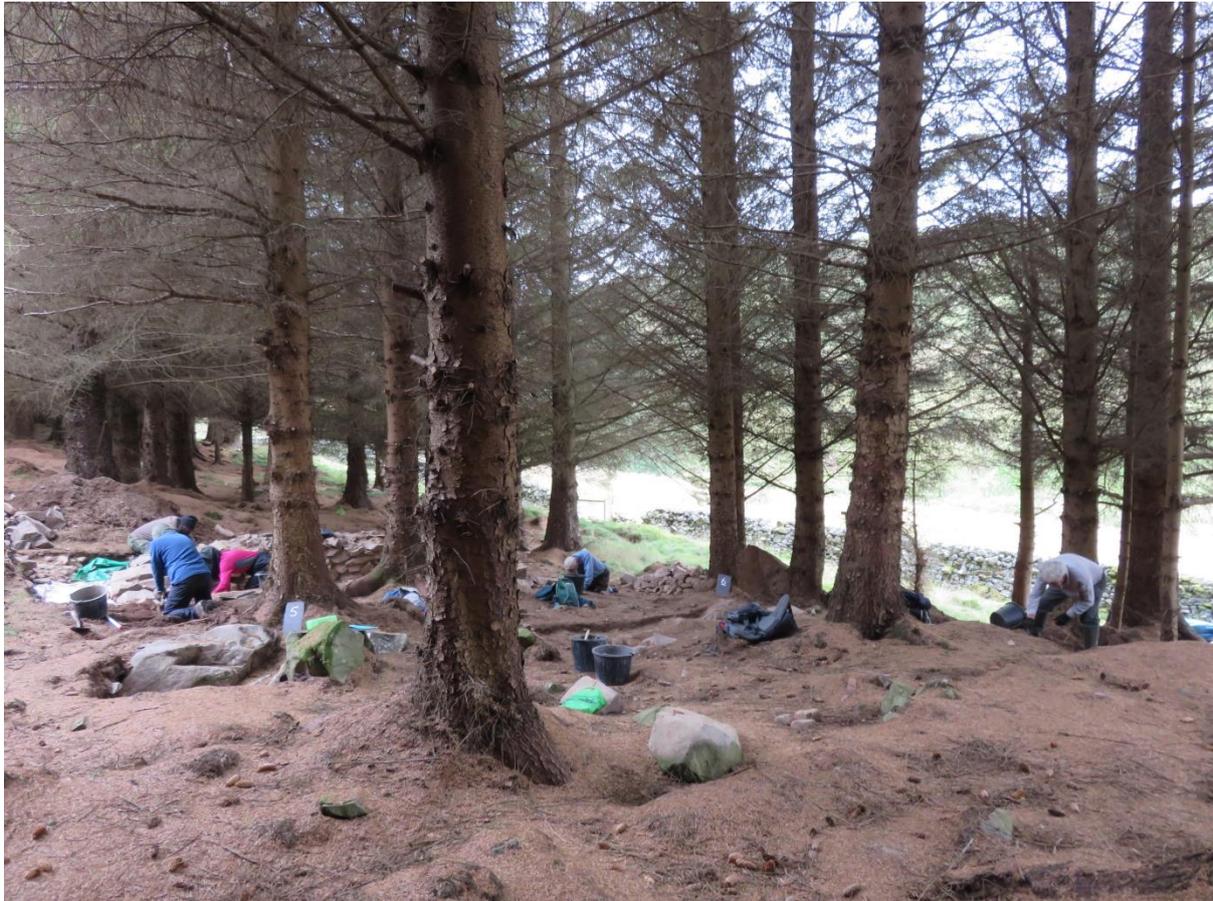
Figure 1 The house platform early in the excavation in 2015 with trenches 4 and 5 under excavation. Forestry plough furrows may be seen running across the platform.

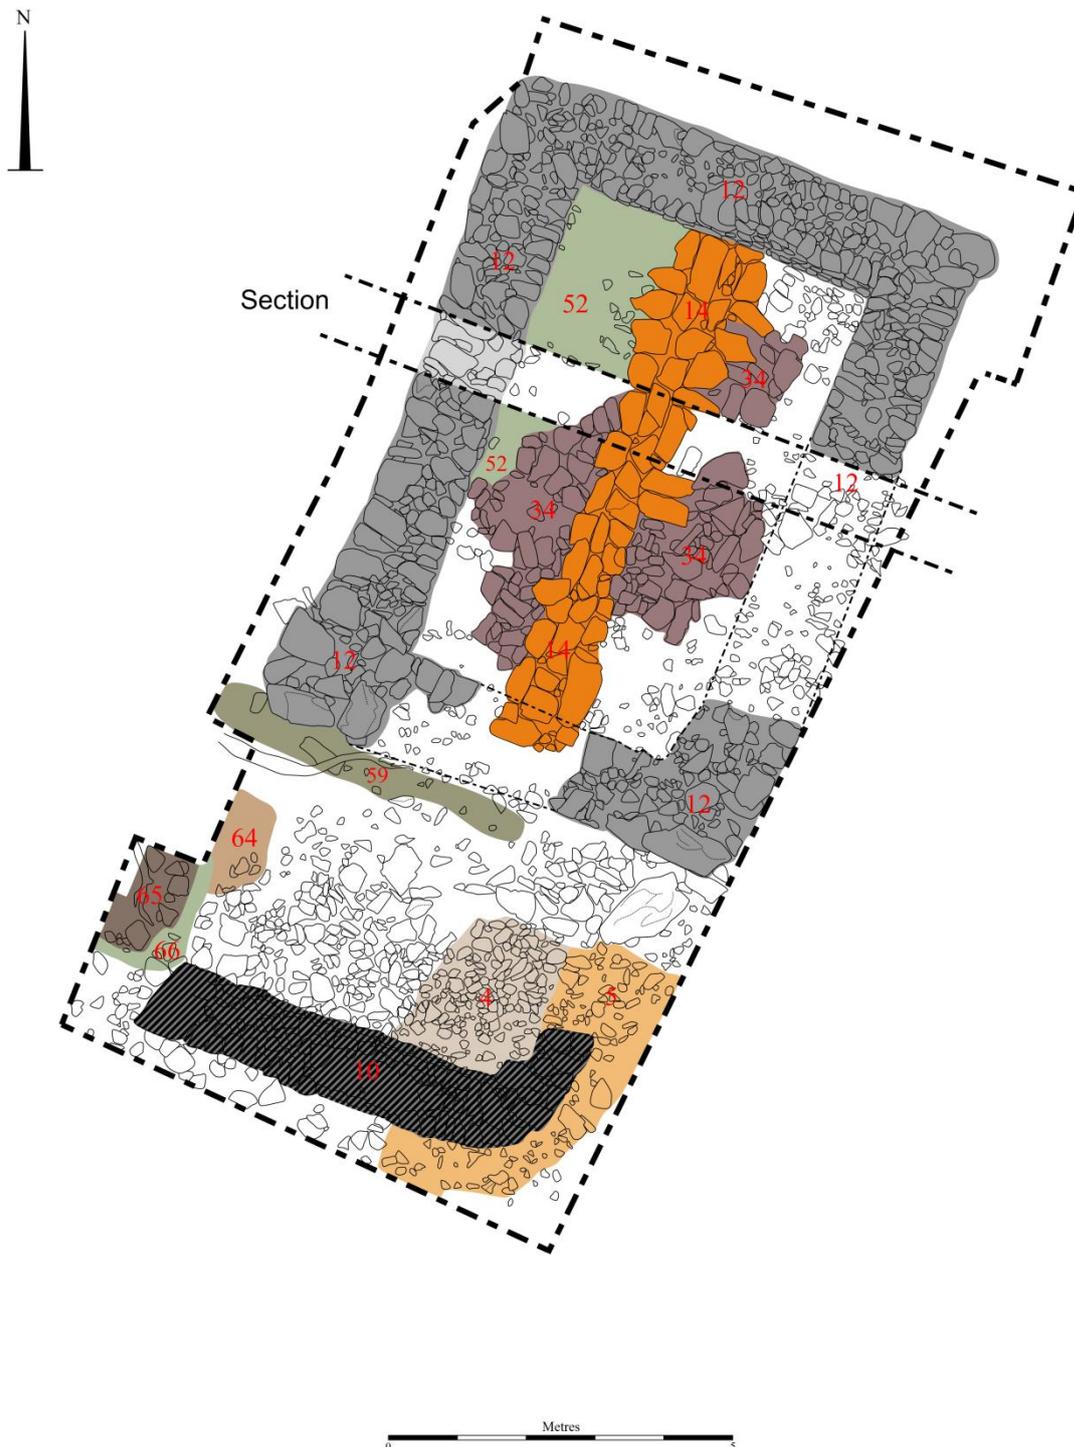
Figure 2.1 Plan showing Phase 1 of the peel house with outbuilding wall (65) to SW and a box section cut across the building (Figure 3). Later wall 10 from Phase 2 hatched, overlies earlier cobbled yard surface 4 and 5. Plan based on aerial image, dated 26/8/2019.

In the south-west corner of the trench where the ground sloped down (Figure 2.1 and 5), the wall of a building (C65) was located which was aligned on the same axis as the peel house, but had narrower walls. Terraced into the slope of the ground to a depth of c.0.20m, with a narrow construction trench visible on its east side (C66) filled with medium sized stones and brown silt (C67), it measured 0.65m in thickness and like the peel house was built with large and medium sized rubble with a brown clay-silt bonding (C70). It stood to two courses in places, c.0.3m in height, and c.1.65m of its length was revealed in the trench and it appears to turn west at its south end to leave the trench on the evidence of the cut of the construction trench. This building was sealed under a red-brown silt layer (C6/50) that had been used as make-up for the extension to the building in phase 2. This layer also overlay what may be a demolition trench for the building that was cut into the underlying subsoil to a depth of 0.12m at its east but deepened 0.25m to the west (C64). The trench was 2m long and 0.8m width at its greatest. Part of the construction trench for the building became visible once it had been emptied of its primary fill of brown and yellow clay silt (C63) and upper fill of mottled darker and lighter brown clay (C62). No clay pipe was found in any of the contexts associated with it.

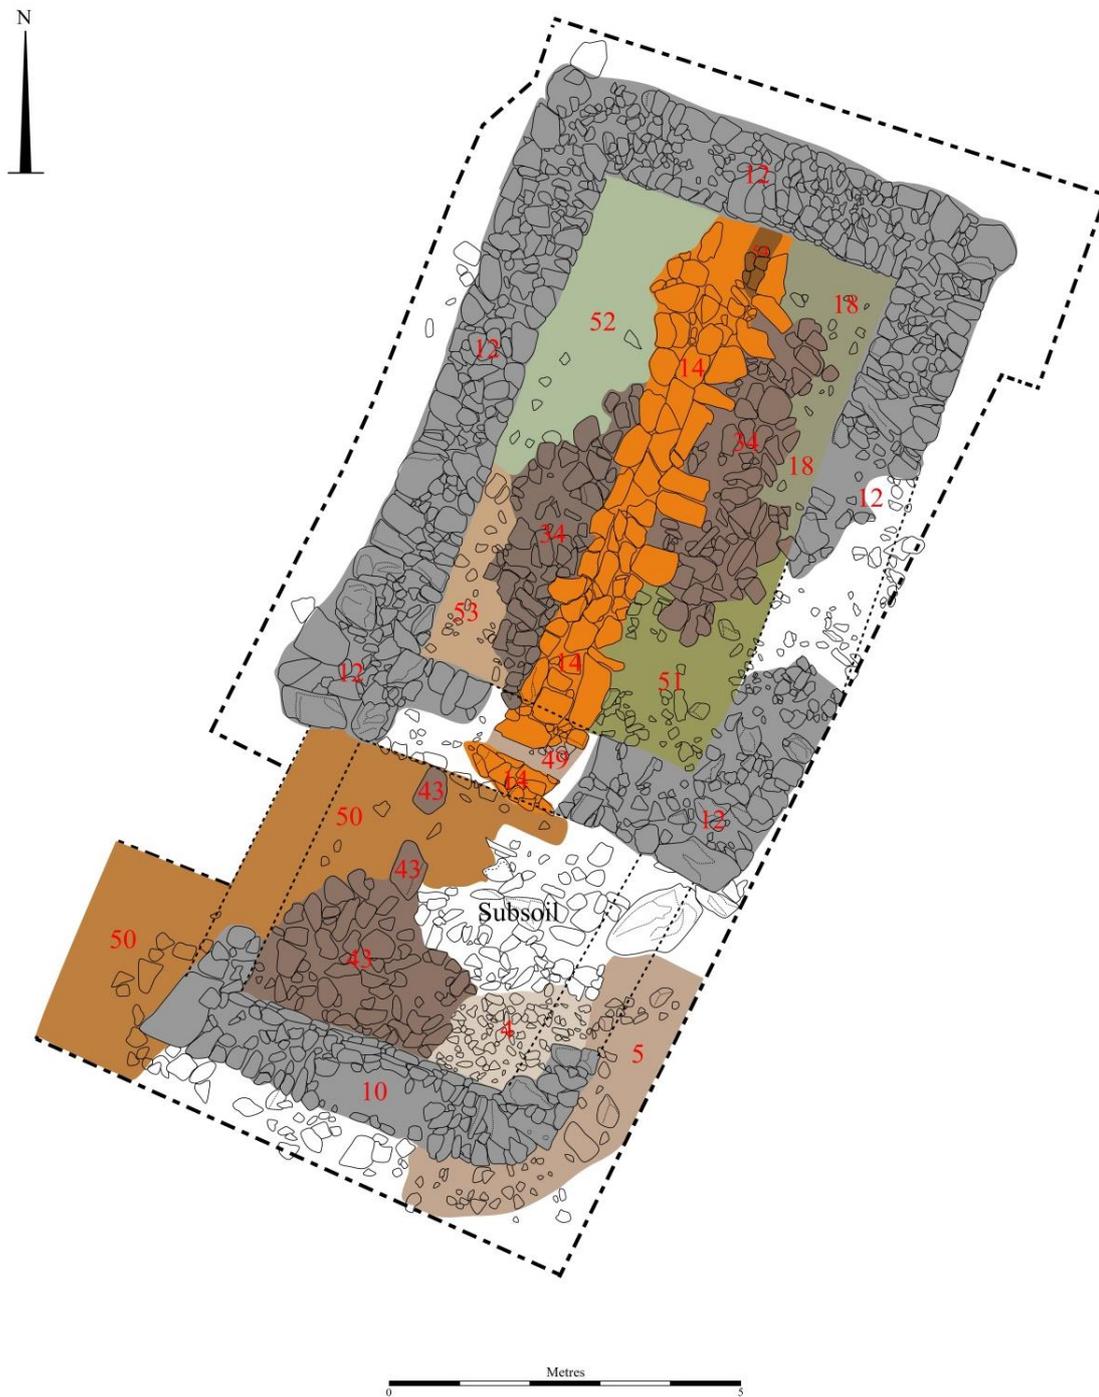
Figure 2.2 Plan of Phase 1 peel house with paving 34 and clay floors 18, 51, 52, 53. Phase 2 extension to S with paved floor 43. Plan based on aerial image, dated 07/11/2018.

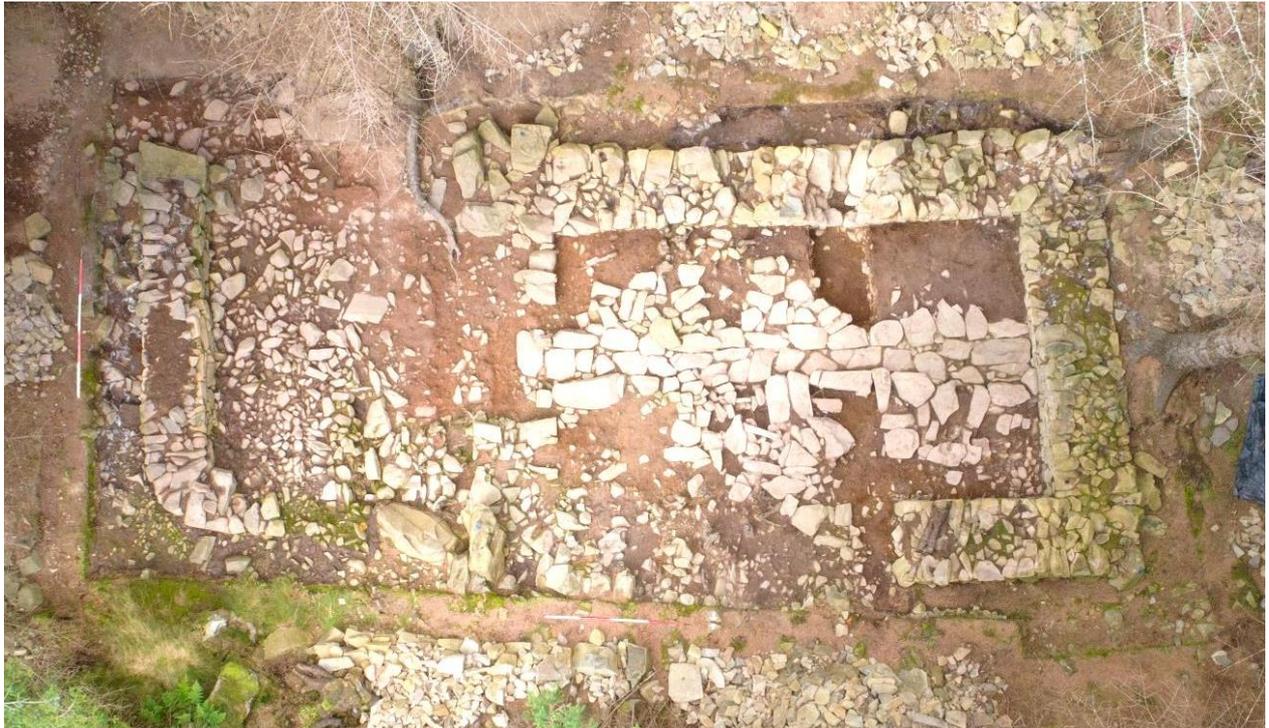
Figure 2.3 Ortho-rectified aerial image of phase 1 of the peel house after excavation of the clay floors and E-W 1m wide box section. The extension was completely excavated except for the south wall. Outbuilding wall C65 is visible top left. North is to the right of the image, dated 26/08/2019.

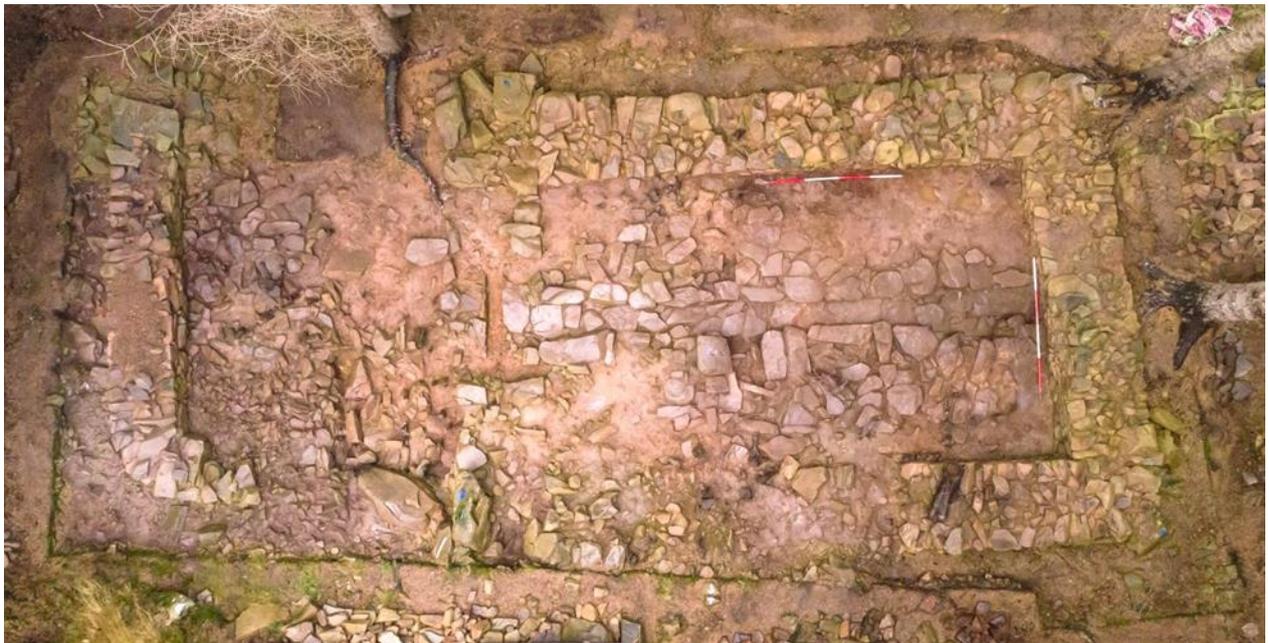
Figure 2.4 Aerial photograph dated 07/11/2018 showing primary floors of peel house.

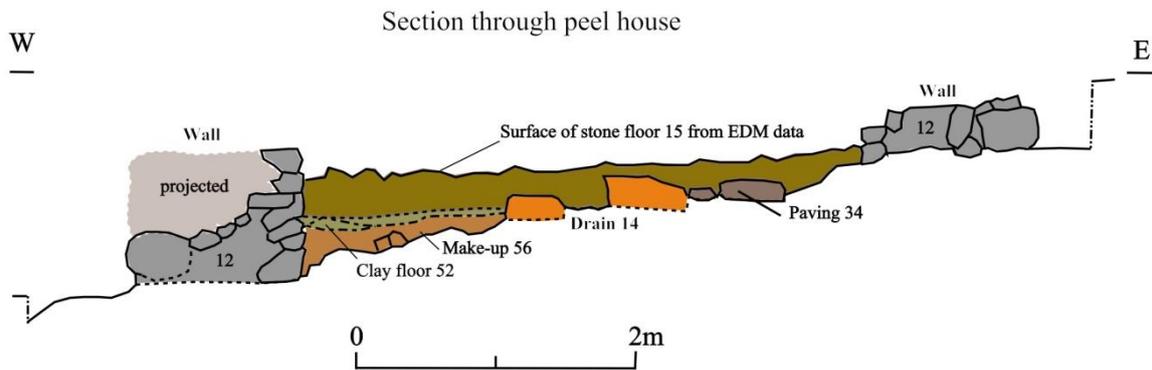
Figure 3 Drawn W-E section of the peel house showing the primary byre drain, paving and make-up, with the surface of secondary stone floor 15 over (profile added from EDM data recorded 31/07/2018).

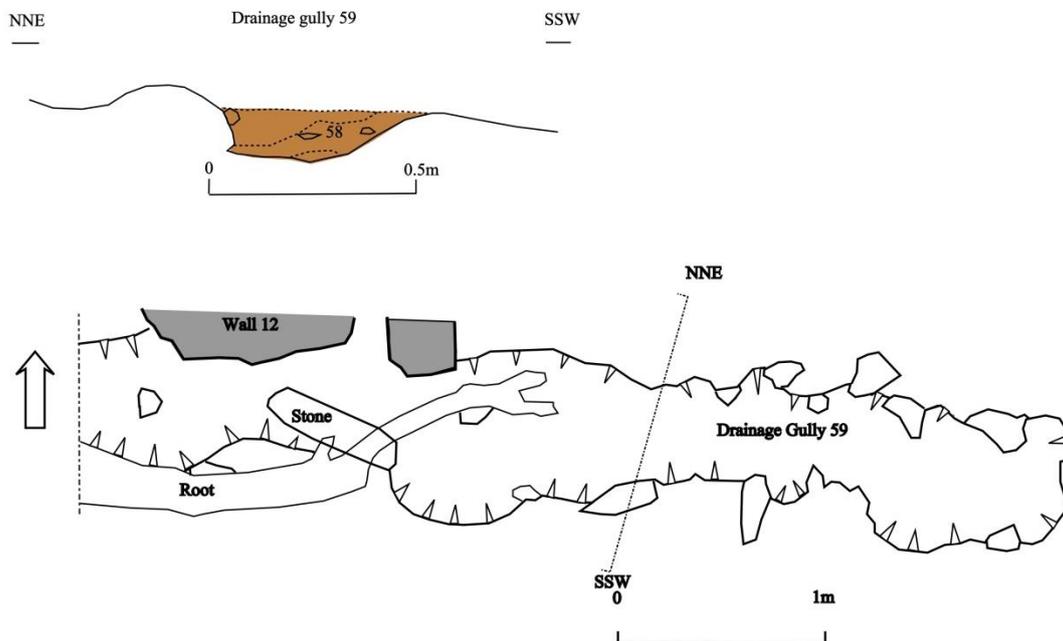
Figure 4 Section and plan of the east-west drainage gully (C59) outside south wall of the peel house (C12).

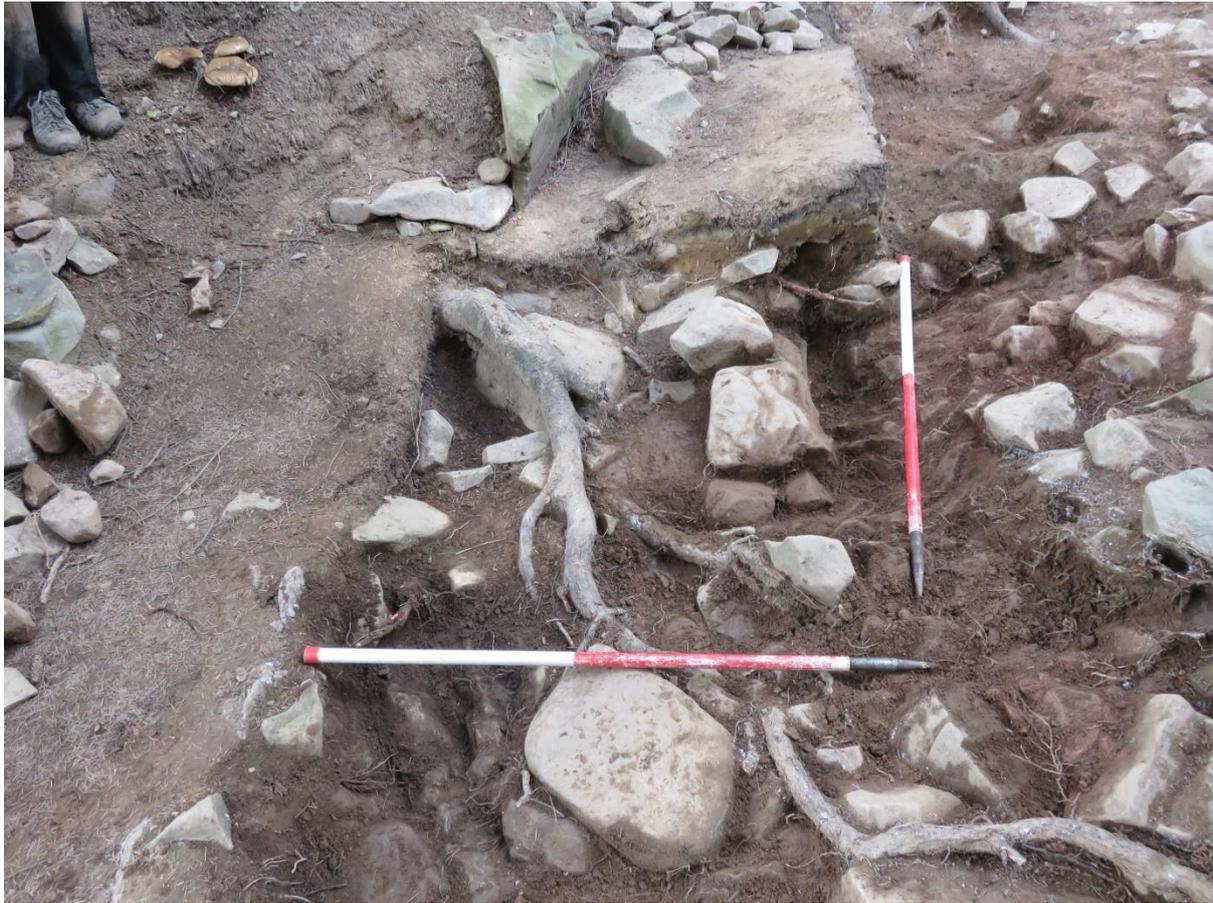
Figure 5 Wall of outbuilding C65 from the S with the construction trench C66 visible on its right hand side.

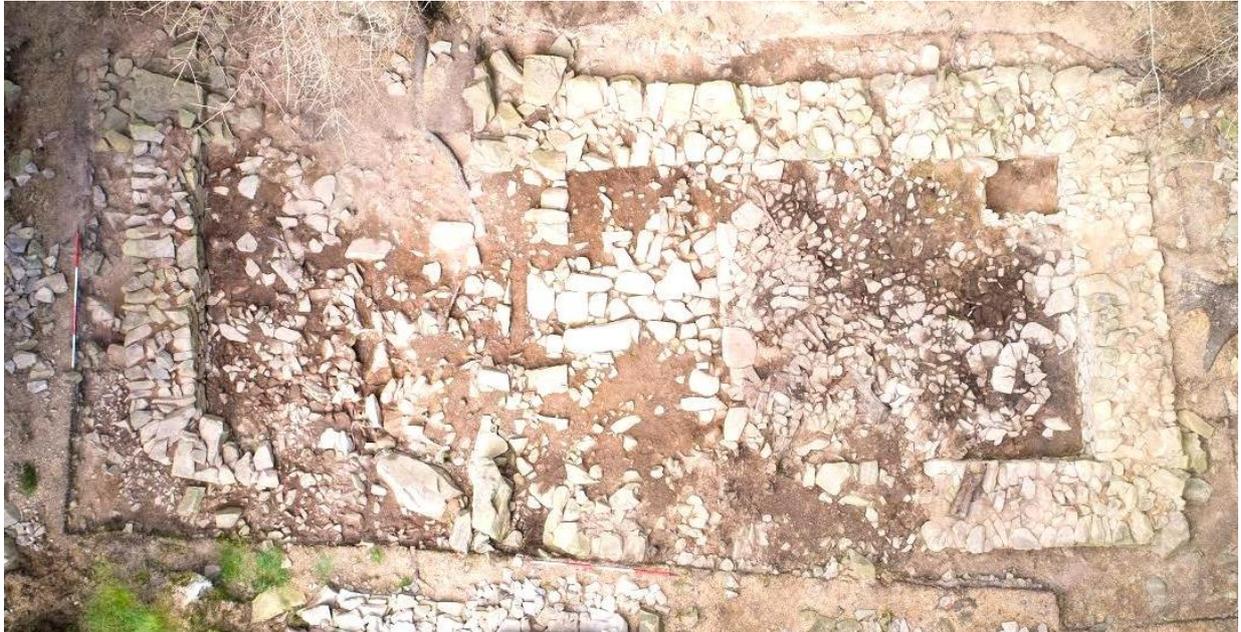
Figure 5.1 Ortho-rectified aerial image of phase 2 showing the raised stone floor with hearths overlying the primary byre drain and the extension to the left of it. North is to the right of the image. Aerial image dated 23/07/2018.

This phase encompasses the remodelling of the peel house into a domestic house with a ground floor kitchen occupying the northern two-thirds of the structure. The equivalent floor of the south part was missing, but an entrance at the same level was noted in the east wall at this end. It is assumed for the sake of simplicity that the extension of the house to the south belongs to this phase (Figures 5.1 and 5.3).

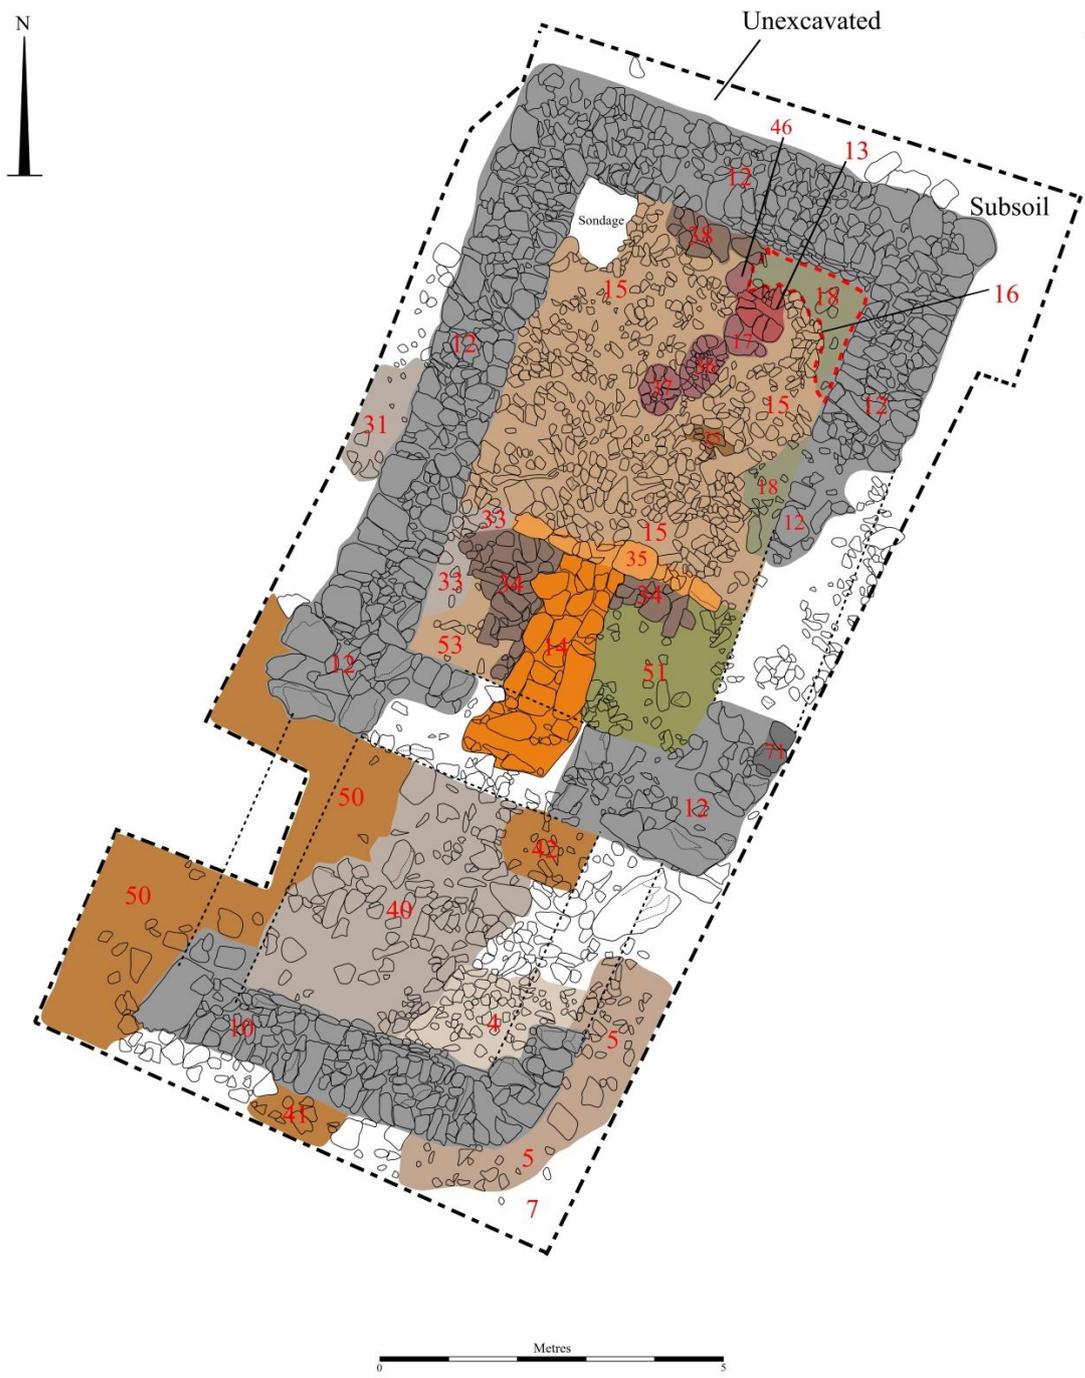
Figure 5.3 Plan of Phase 2 also showing the south extension. The stone floor 15 was reveted by an edge of stones C35 and contained a row of hearths five hearths, C36, C37, C17, C45, C46 (Phase 4 Hearth 13 overlay C45). No equivalent floor was found in the S part of the peel house and the underlying Phase 1 floor is depicted in this area. Layer 40 in the extension to the S is a burnt layer spread over the underlying floor 43. Plan based on aerial image dated 23/07/2018.

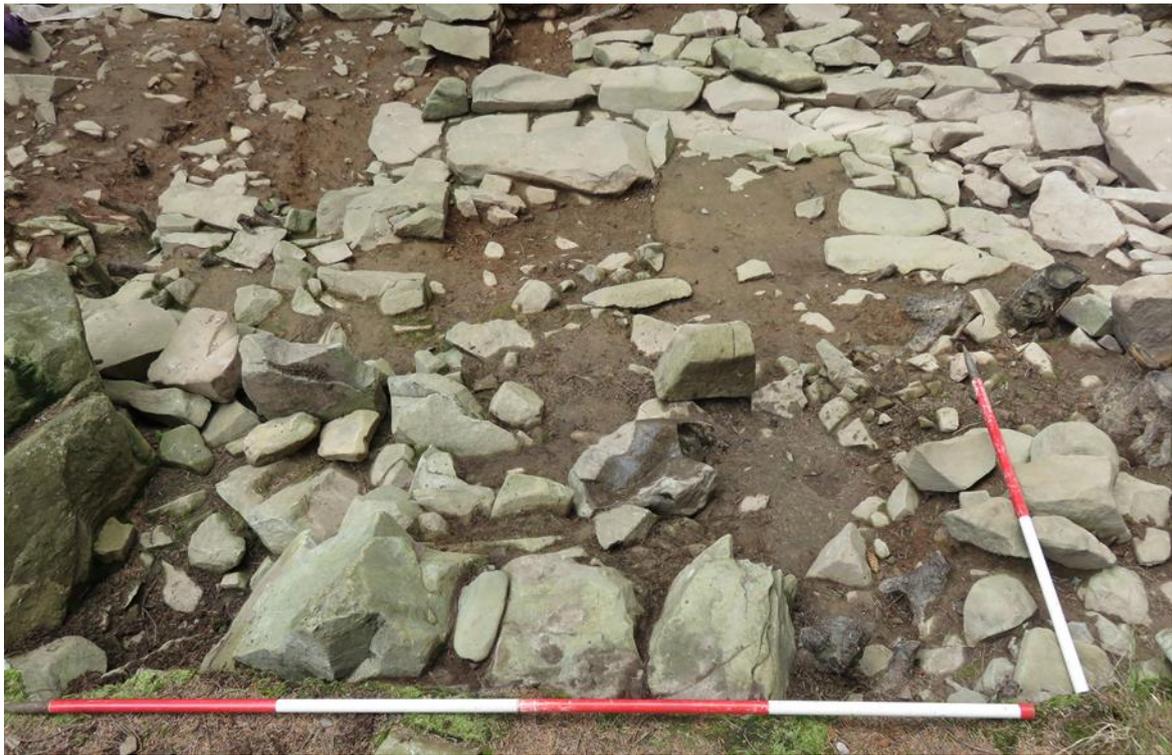
Figure 5.4 The two threshold stones in the E wall (C71) showing signs of smoothing due to wear. It indicates the location of a rear entrance to the peel house in its secondary phase of occupation at a higher level than the primary byre floor in the background.

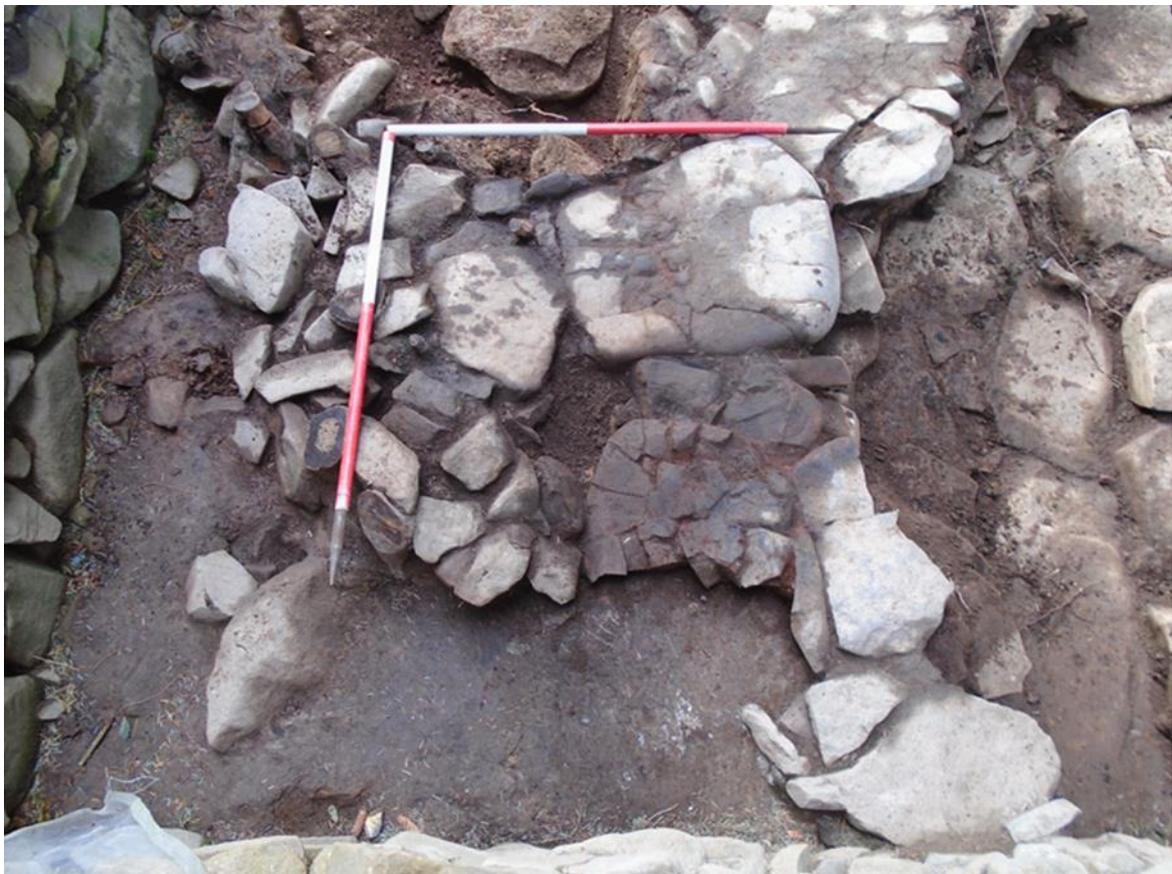
Figure 5.5 Hearth 45, revealed on removal of Phase 4 hearth 13, lying between hearths 17 and 46.

On top of the byre drain and surrounding clay and paved floor described in phase 1, the northern two-thirds of the interior of the peel house was raised by the insertion of a closely packed floor of medium sized stones set on end in a red-brown clay matrix with frequent cavities where the clay had dropped through gaps between in the stones (C15). At its west side the stone floor stood to a depth of 0.4m in height over the phase 1 surface, but was only a maximum of 0.25m at the east side (Figure 2). Underneath the stone floor there was a spread of yellow and brown silty clay containing some large angular stones (C44) of variable depth, but generally no more than 0.05m to 0.1m in depth forming a base for the stone floor. The surface of the floor was a relatively level cobbled surface in the middle of which there was a hearth stone which had broken in the middle (C37) with adjacent hearth stone hearths in echelon towards the north-east corner (C36, C17, C45, C46). All the hearth stones comprised flat river-washed greywacke, all of which had shattered due to the heat of the fire. Along the east and north walls an L-shaped area of the stone-floor (up to 0.5m across) was absent, possibly robbed (C16) to a depth of up to 0.15m, revealing a mixed layer of yellow and brown clay with charcoal beneath (C18, see phase 1 above). In the middle of the north wall and adjacent to the north-most hearth stone (C46) was an area of paving 1.3m in length and 0.65m in width (C38). The south edge of the stone floor comprised a kerb of large oblong stones (C35) that ran east-west across the whole breadth of the house except for a short gap of 0.5m at the west end, which had been robbed. A small line of flat paving stone lay against the west wall at this point, possibly from the threshold of an entrance into the adjacent room. Apart from these features there was also a small hollow in the floor about 0.7m east of the central hearth C37. It is not clear if this was an intentional feature or subsidence. The total absence of any structural remains at this level to the south of this floor suggests there was a timber floor at this end. Three smoothed stones were observed in the outer edge of the east wall just north of the south-east corner at about 0.3m above the level of the drain, possibly indicating an entrance into the house (Figure 5.5).

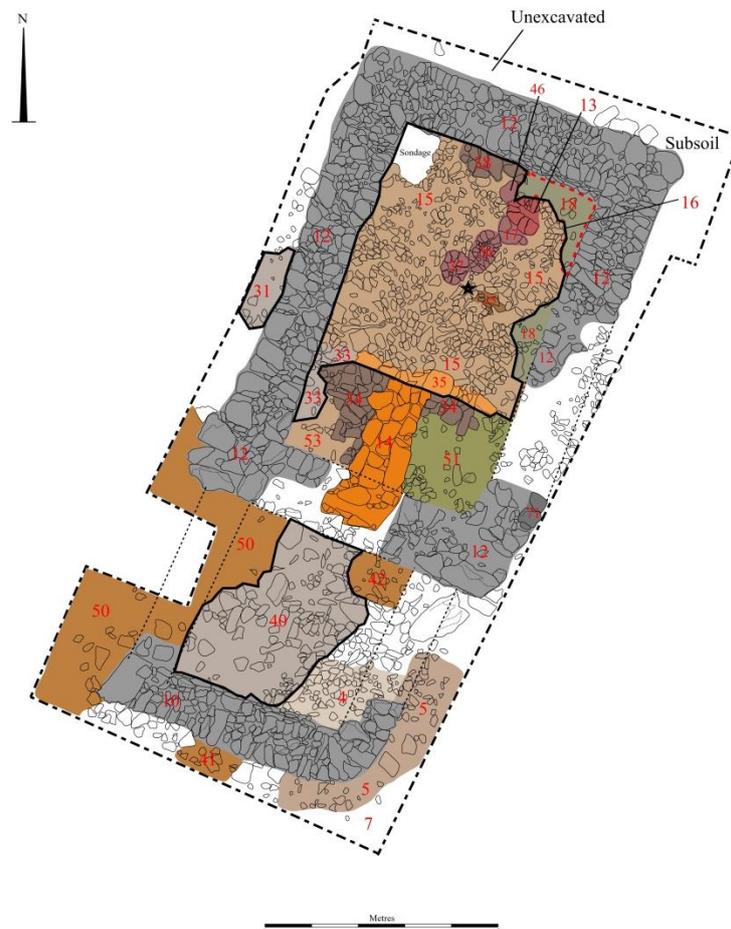
Figure 6.1 Burnt deposits outlined with box sample location marked by star.

This phase is marked by the spread of burnt material across the stone floor of the phase 2 house suggesting the house was burnt down (Figure 6.1). The amount of burnt material over the paving in the extension appears to place the two events together, although this would be difficult to prove. The burnt layer comprises mottled dark brown and grey silty clay with frequent fragments and comminuted particles of charcoal, with occasional medium stones and large stones (C3) which spread across the whole of the stone floor (C15). Lenses of reddish brown silt suggest burnt turf. The thickness of the deposit varied according to the unevenness of the cobbled floor. For the most part the deposits were only a few centimetres thick, but it was up to 0.15m in places (Figure 6.2). A box sample was taken from the thickest part of the deposit for analysis (S30). Frequent pieces of charcoal and clay pipe were recovered from the deposit including a complete bowl (F166) dated c.1650-70 and a sherd of 17th century Frechen stoneware (F98). Some of the burnt deposit was spread beyond the edge of the revetment of the floor onto the byre floor below, especially in the south-west of the building (C33). A Frechen bottleneck with face mask was found in the burnt deposit C33 (F213). There was an absence of burnt deposits elsewhere at the S end of the peel house where post-occupation deposits lay directly on the Phase 1 floor. In the south extension the burnt material (C40) was composed of mottled orange brown clay and dark brown silt with charcoal flecks and was mainly found where there was paving, but was not observed elsewhere. The post-occupation robbing of the walls to east and west may also have included removal of some of the paving, both of this phase and the later phase of floor (C11).

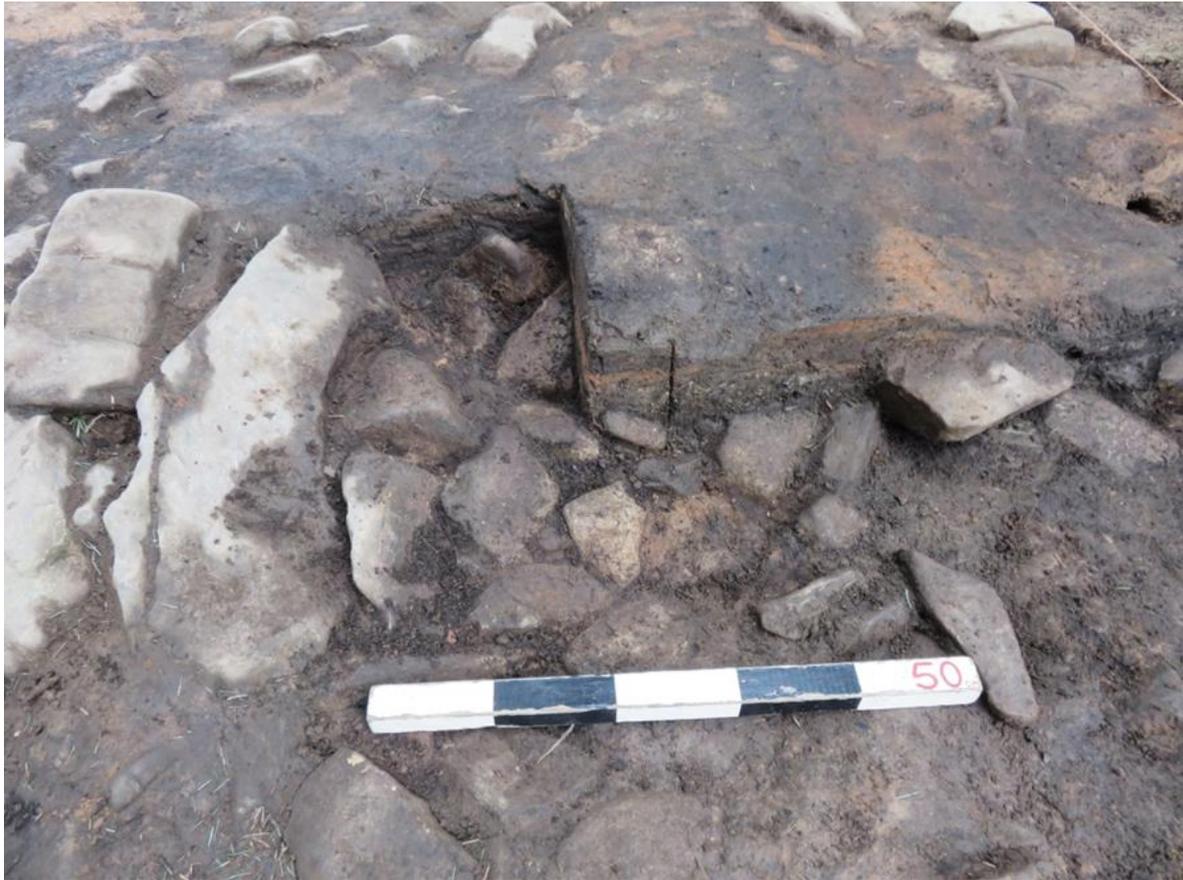
Figure 6.2 The burnt deposit showing the location of the box sample (S30), plan location on Figure 6.1.

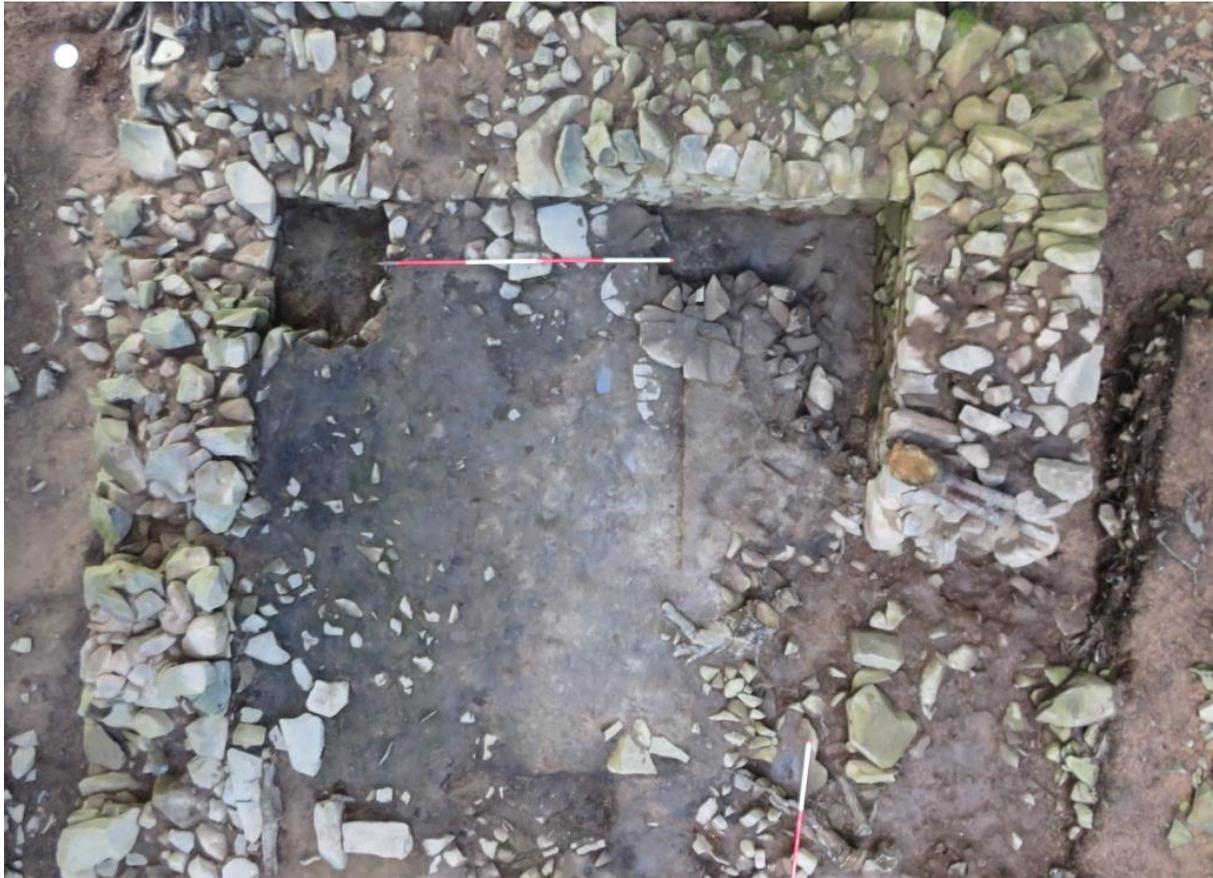
Figure 7.1 Aerial photograph of the grey clay floor-surface (C19) with broken hearth stone (C13) which it abuts to the right of the ranging pole. The dark grey area on the left alongside the wall is the burnt layer (C3) that underlies it showing through the grey clay while under excavation to the left of the section line. The two large stones at the bottom left of the floor (C22) may be a base for a timber partition.

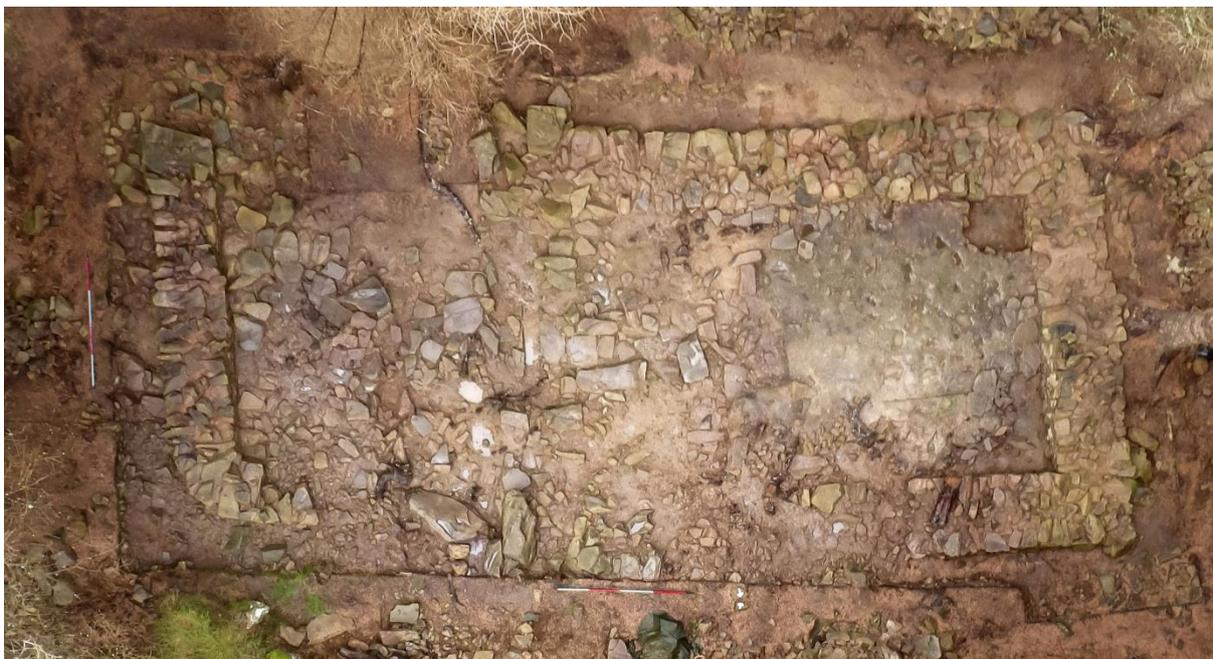
Figure 7.2 Vertical aerial photograph dated 9/9/2017 showing the final phase of occupation.

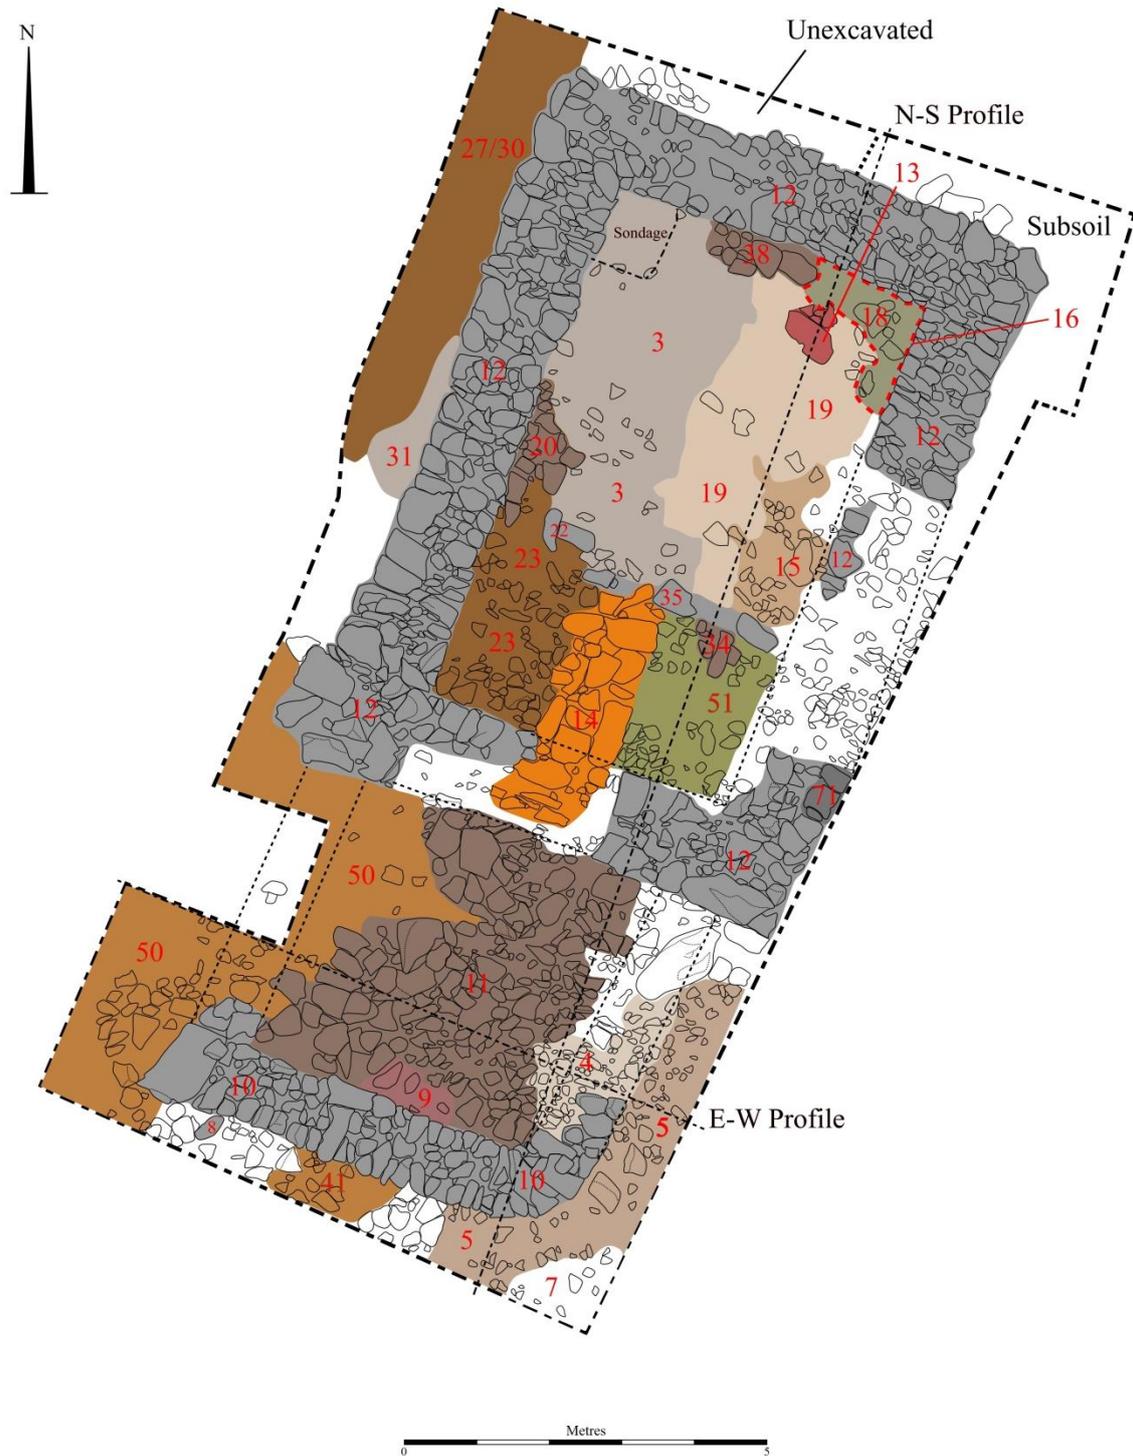
Figure 7.3 Plan of Phase 4: Building 2. Grey clay layer 19 extended over layer 3, but was thinner to the W and not defined until it became thicker, but see sondage Figure 10. Plan based on aerial image, dated 9/9/2017.

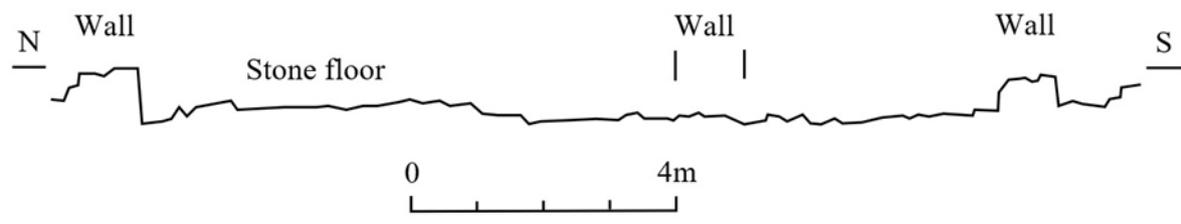
Figure 7.4 N-S Profile across Phase 4 floors. (EDM data 24/08/2017)

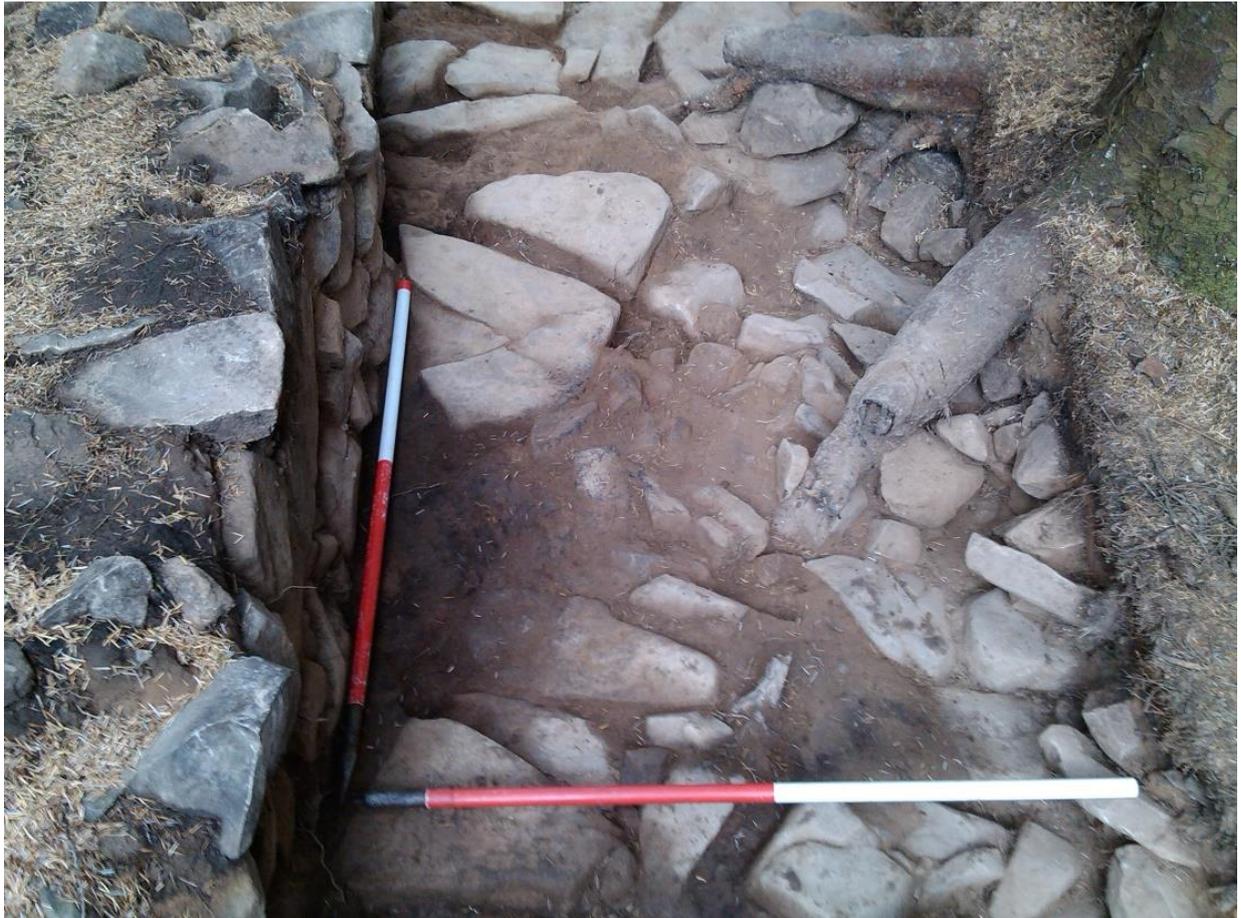
Figure 8 Phase 4 hearth (C9) in the extension against the south wall (C10) set on a layer of paving (C11). The reddened soil may be seen in beside the wall.

In the extension a new paved floor (C11) was laid over a make-up of dark brown silty deposits (C28 and C32). A hearth (C9) forming a hollow in the paved floor was established on this paving against the middle of the south wall, with signs of reddening of the matrix of the paving due to heat. It was partly filled with grey clay and angular stones (C21), indicating domestic use of the south extension (Figure 8). A soil sample of the hearth fill was taken.

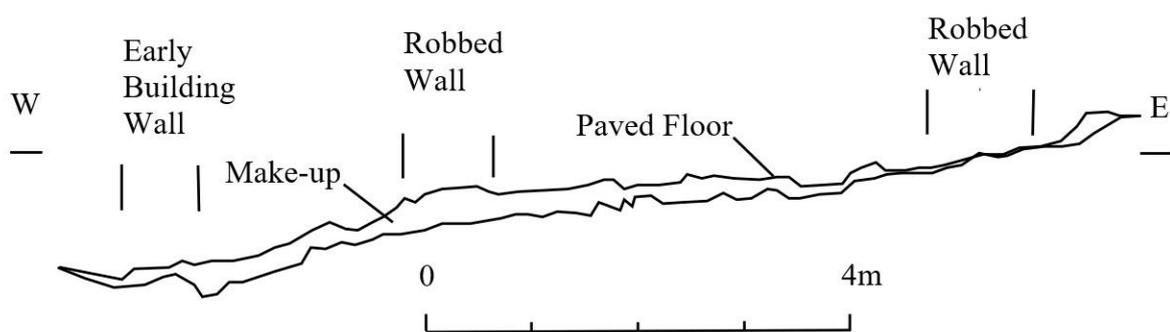
Figure 9 W-E profiles across the extension to Building 2 (Upper 26/08/2017, Lower 26/08/2019). The upper surface shows the paved floor of the extension (C11) before excavation and the lower after excavation of it and make-up (C50). The wall of primary phase structure C65 is at a lower level. See Figure 5.3 for line of profiles.
