Shootinglee Trenches 3-5 2015-2019

Data Structure Report

Building 2

Peeblesshire Archaeological Society 2024

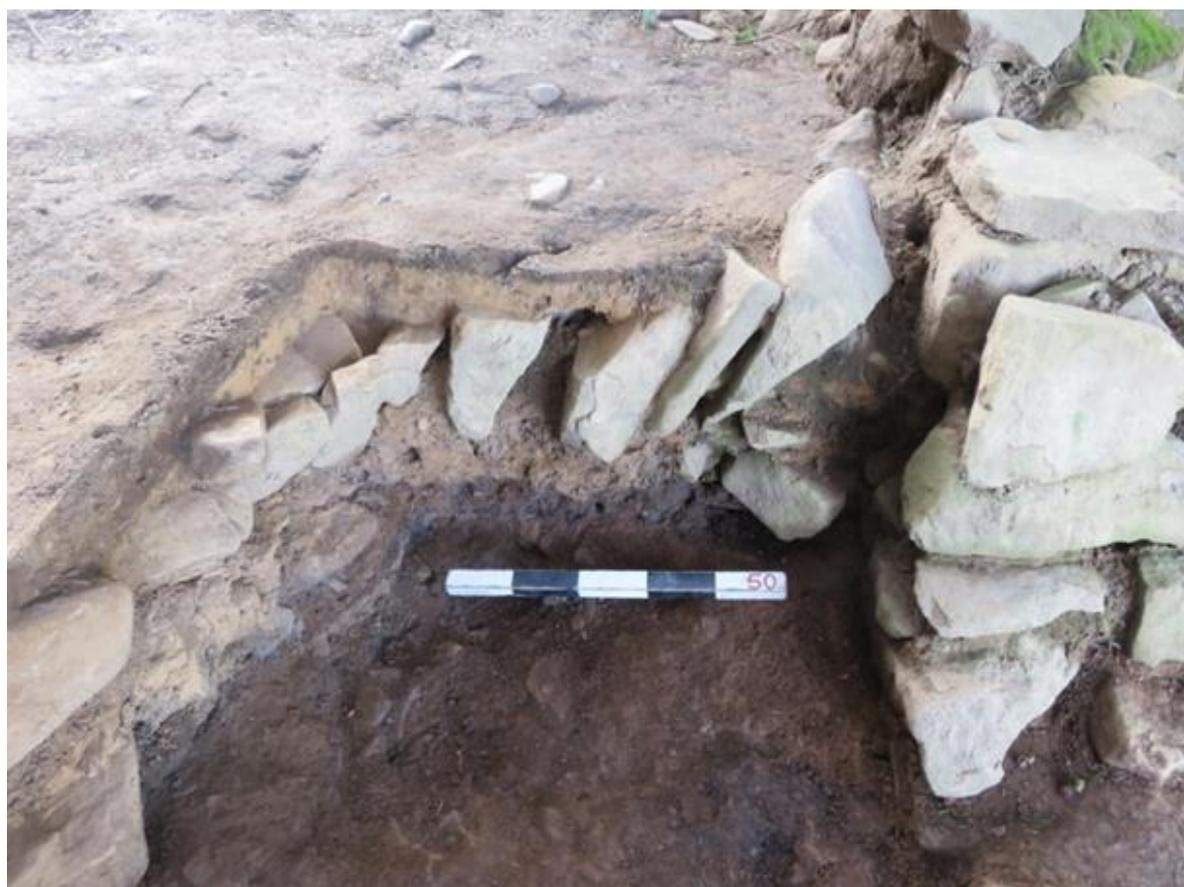
Figure 10 Trench 3 sondage north-west corner, showing successive floor levels; the final grey clay floor (C19) over a thin band of charcoal rich layer (C3), the brown clay and end-set stones of the raised floor (C15) and below that orange silty clay make-up (C44) over a dark grey clay (C48) that was spread over the primary mixed yellow and red-brown clay floor (C52). West wall (C12) to right.

Figure 7.3 Plan of Phase 4: Building 2. Grey clay layer 19 extended over layer 3, but was thinner to the W and not defined until it became thicker, but see sondage Figure 10. Plan based on aerial image, dated 9/9/2017.
